17 March 2011

## Tsunami Roulette – A Pictoral Tsunami Report

by Thomas R. Cannon, Architect, A.I.A., Chair, Maui Island General Plan Advisory Committee

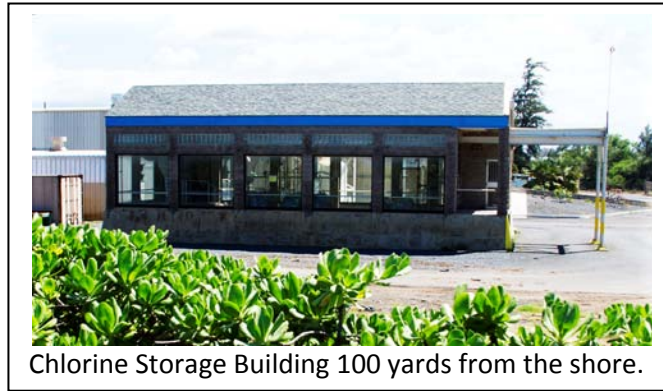
Chlorine Storage Building 100 yards from the shore.

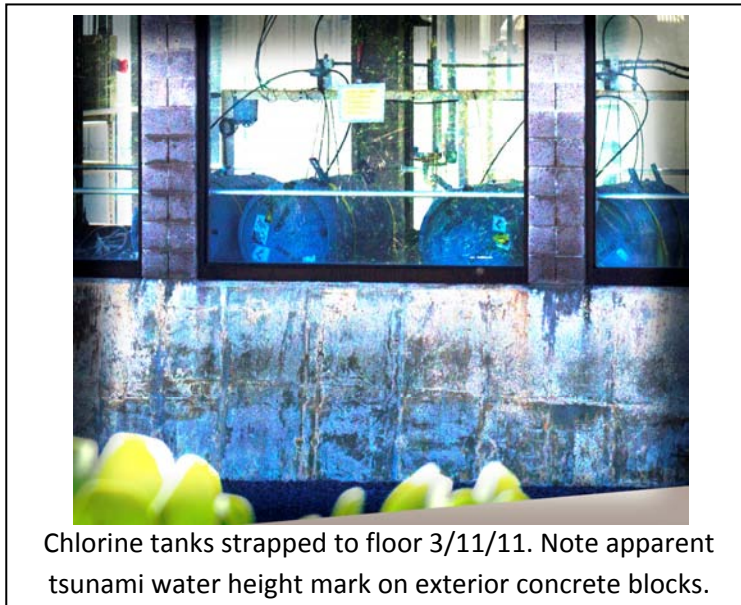
Chlorine gas is heavier than air and stays down near people until dissipated. It was used as a weapon in World War I, and causes a terrible death. All that separates the KSTP tanks from a tsunami are a number of large glass windows, which are supposed to allow the waves to wash through the building leaving the tanks strapped down to the concrete floor.

Chlorine tanks strapped to floor 3/11/11. Note apparent tsunami water height mark on exterior concrete blocks.

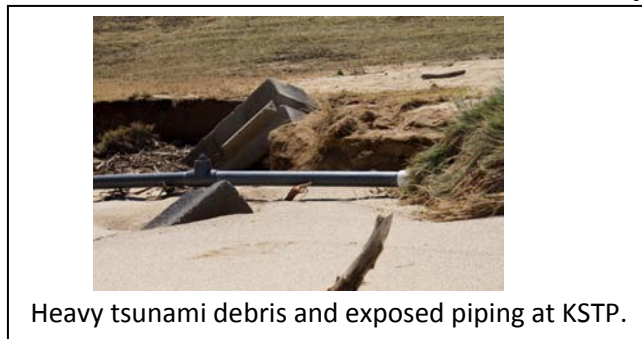
Heavy tsunami debris and exposed piping at KSTP.

Is it reasonable to think that a major tsunami could push debris through the glass windows of the KSTP chlorine storage building rupturing one or more of the liquid chlorine tanks? The effects of the March 11, 2011, tsunami clearly show that scenario is possible. Most of the KSTP makai perimeter fence was destroyed by the March 11 waves, pipes were exposed, debris including heavy concrete blocks and large steel pipes and fittings were strewn about the site.

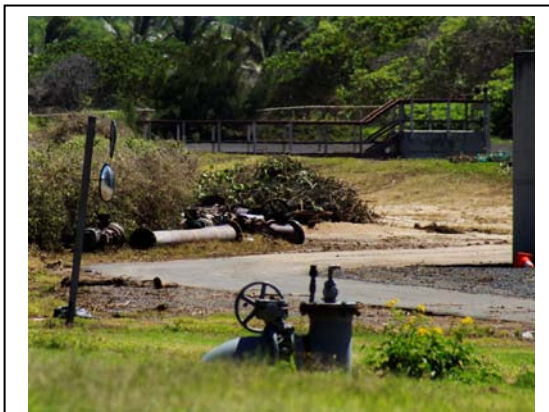
An assortment of iron pipes and fittings ended up about fifty feet or so from the chlorine storage building glass windows. It seems reasonable to believe that they could have just as easily ended up inside the glass windows. Especially, with the apparent high water mark pictured above.

Large, heavy, iron pipe tsunami debris.

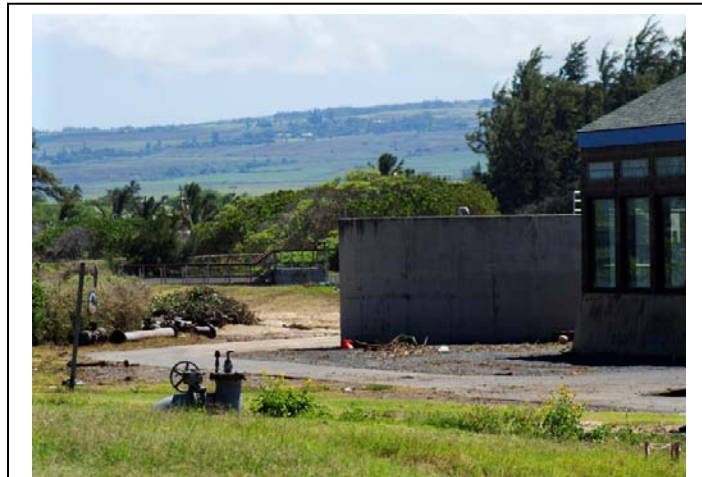
Loose iron projectiles landed near chlorine storage.

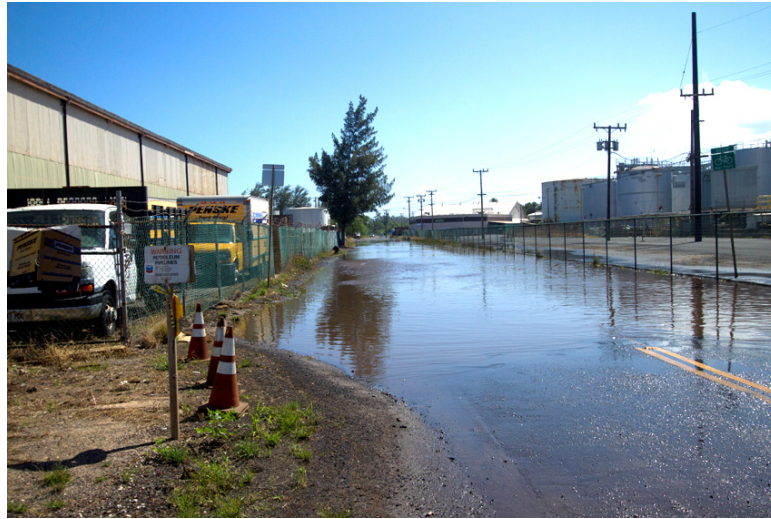
In addition to the potential for damage from a tsunami hitting the sewage plant, huge fuel tanks, and Maui Electric's Kahului generation plant are also located in the flood zone, a stone's throw away. Warehouse buildings the size of that shown in the left of the photo below were pushed sideways great distances by the March 10 Japan wave, crushing anything in their path, as seen on TV. Our March 11 wave may have just touched the Kahului fuel tanks. So, with that evidence, are we okay just keeping things as they are in the General Plan, crossing our fingers that the next tsunami won't be the big one? These problems are not unsolvable, and resolving them will provide much-needed jobs.

By the height of the debris lodged between truck and fence at left, the 3/11/11 wave may have just touched the fuel tanks, before receding a few hours later (when this photo was taken).

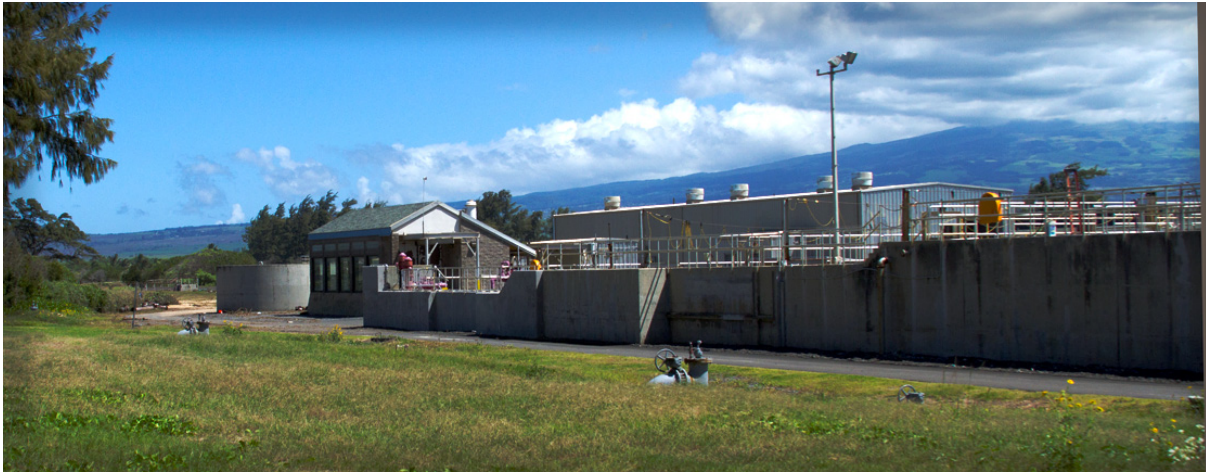
KSTP on the shore in the Tsunami Flood Zone

The 25-member Maui Island General Plan Advisory Committee (or GPAC) recommended Maui County “Immediately begin to phase out the Kahului sewage treatment plant and provide for a new facility out of the tsunami zone.” Maui’s leaders need to include this policy in the current update of the Maui Island General Plan. In the short term, prior to implementing that plan, we might consider temporarily moving the lethal chlorine to safer high ground upon ample tsunami warning. But, time is of the essence, in order to ensure an orderly transition. It needs to be in the Maui Island General Plan, as devastation here, would affect all of Maui County.

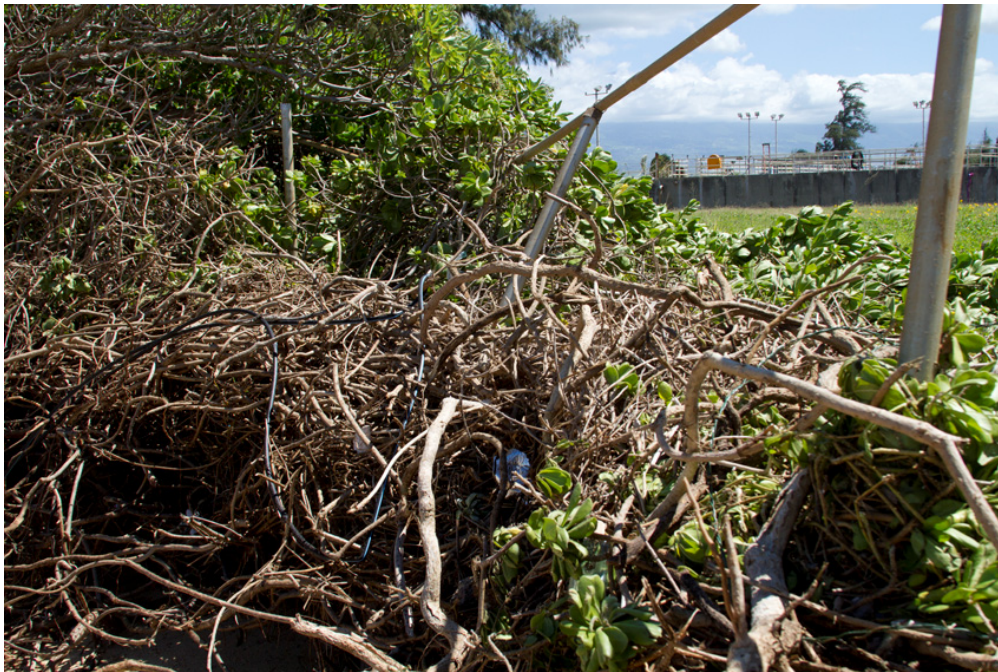
View of the sewage vats from the beach after the 3/11/11 tsunami.
